QA-399  
Harper House  
Centreville  
Private

## INVENTORY FORM FOR STATE HISTORIC SITES SURVEY

Harper Residence

203 South Commerce Street

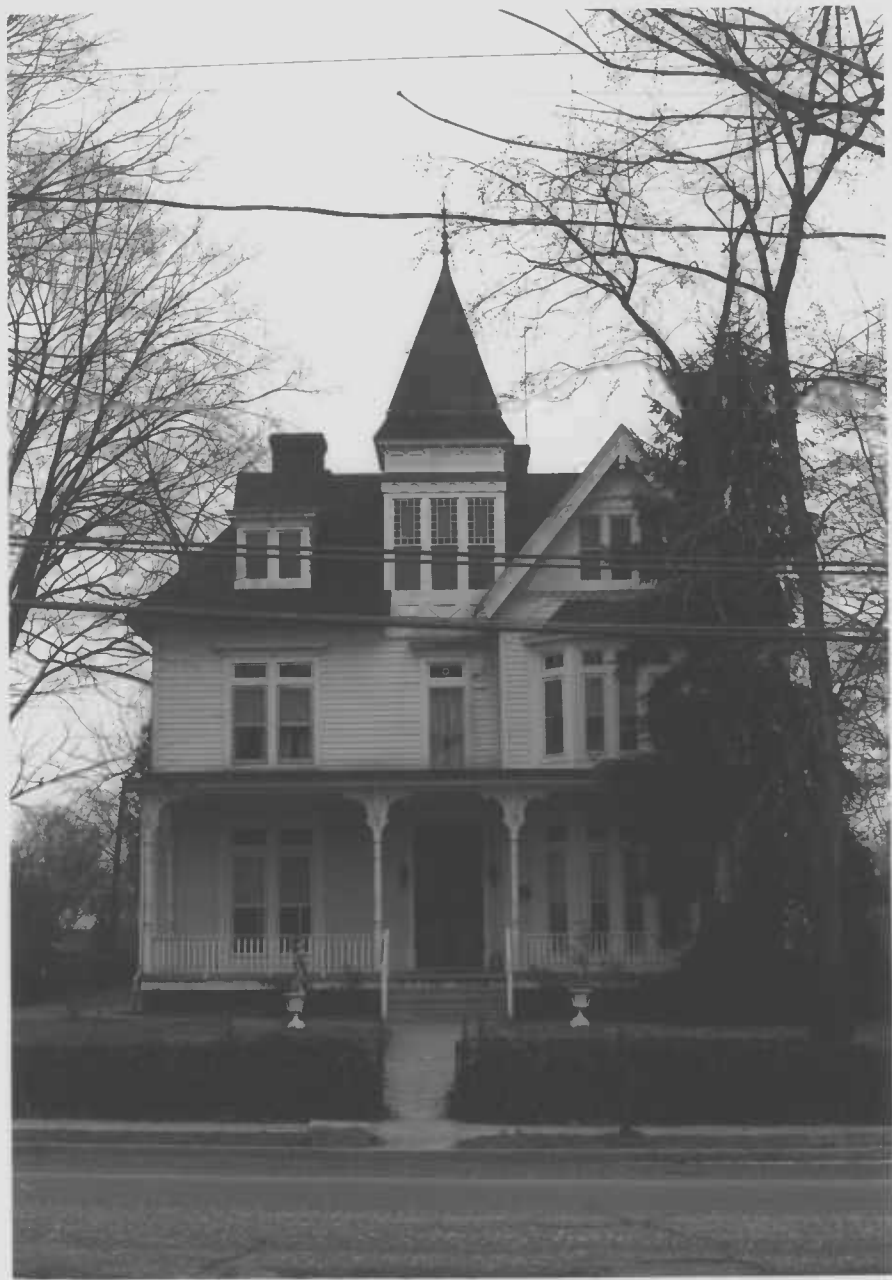
QA-399

Harper House  
South Commerce Street  
Centreville, Maryland  
Orlando Ridout V 1980  
Front facade from West

The front facade, facing west to Commerce Street, is three bays wide, with the south bay consisting of a projecting cross gable. The front door is located in the center bay on the first floor, immediately to the left (north) of the projecting cross gable. The west facade of the cross gable is dominated by a semi-octagonal projecting bay with five 1/1 windows on both the first and second floor. There are three smaller 1/1 windows on the third floor centered in the upper gable and framed with decorative Victorian strapwork and ornate vergeboards.

The center and north bays of the front facade are set back approximately two feet from the projecting cross gable. The front entrance consists

of double doors with a decorative transom and a bracketed hood mold. To the left of the door, in the north bay, a pair of large 1/1 windows projects slightly from the wall surface. A similar fenestration pattern on the second floor incorporates a single 1/1 window in the center bay and a pair of 1/1 windows in the north bay. A large square turret with pyramidal roof is centered on the building on the third story, with a paired 1/1 shed dormer to the left in the north bay. The turret is quite fanciful and highly decorative, with three 1/1 windows facing the street framed with decorative strapwork. The upper sash of these three windows incorporate a band of smaller stained glass panes around the border. The pyramidal roof of the turret is covered with wood shingles, including a band of fishscale shingles, and is topped with a decorative finial.

The front wall is covered with plain horizontal siding; the hip roof with asphalt shingles. All of the first and second floor windows have very fine stained glass transoms and, except for the bay windows, are protected by bracketed hood molds. An original one story porch with turned posts and Eastlake brackets stretches across the front facade.

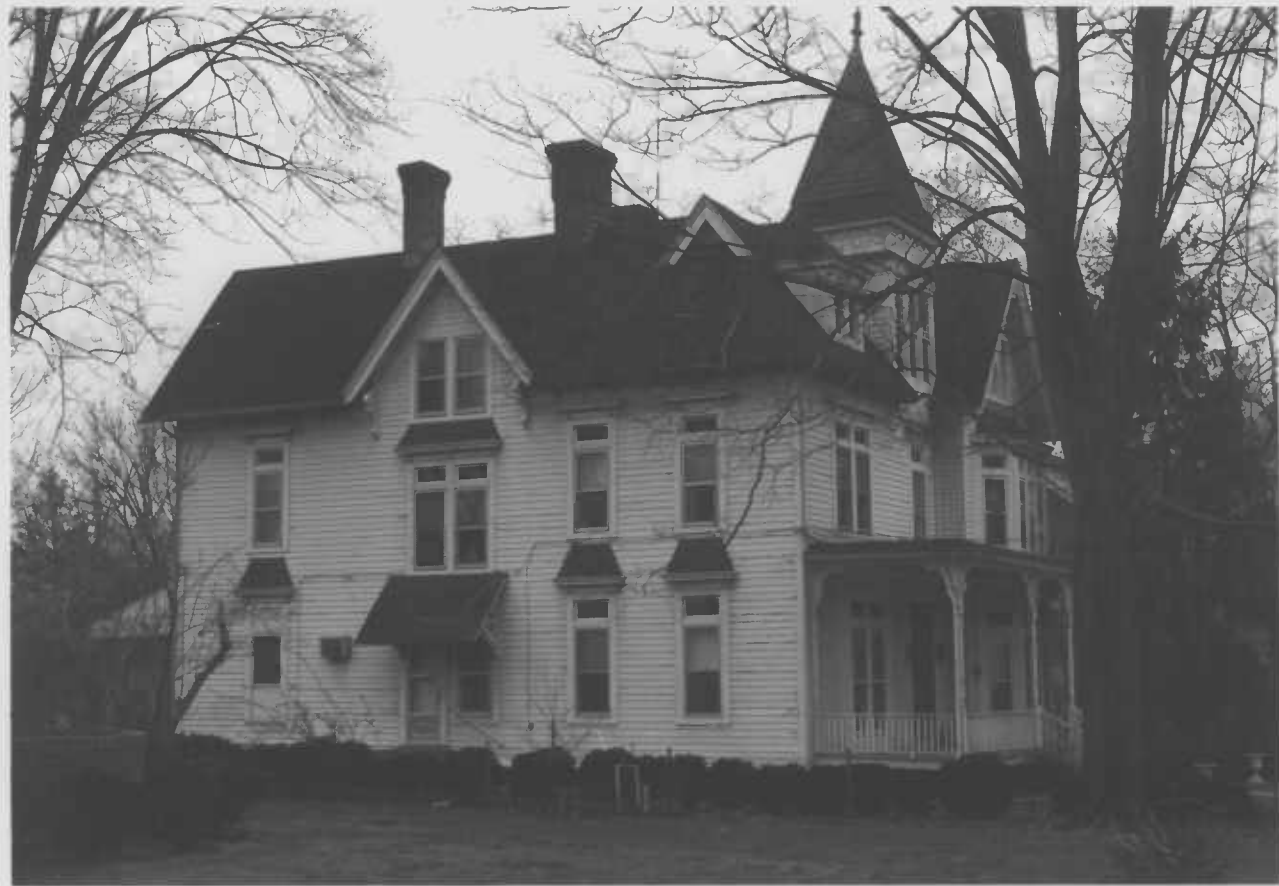
QA-399

Harper House  
South Commerce Street  
Centreville, Maryland  
Orlando Ridout V 1980  
View from Northwest

The north facade has asymmetrical four bay fenestration. A cross gable adds emphasis to the second bay from the east, and a secondary service entrance with an adjoining 1/1 window is protected by paired 1/1 windows on the second floor and in the cross gable on the third floor. There are single 1/1 windows in the east bay and the two west bays on the first and second floor. All of the first and second floor windows have stained glass transoms and bracketed hoods.

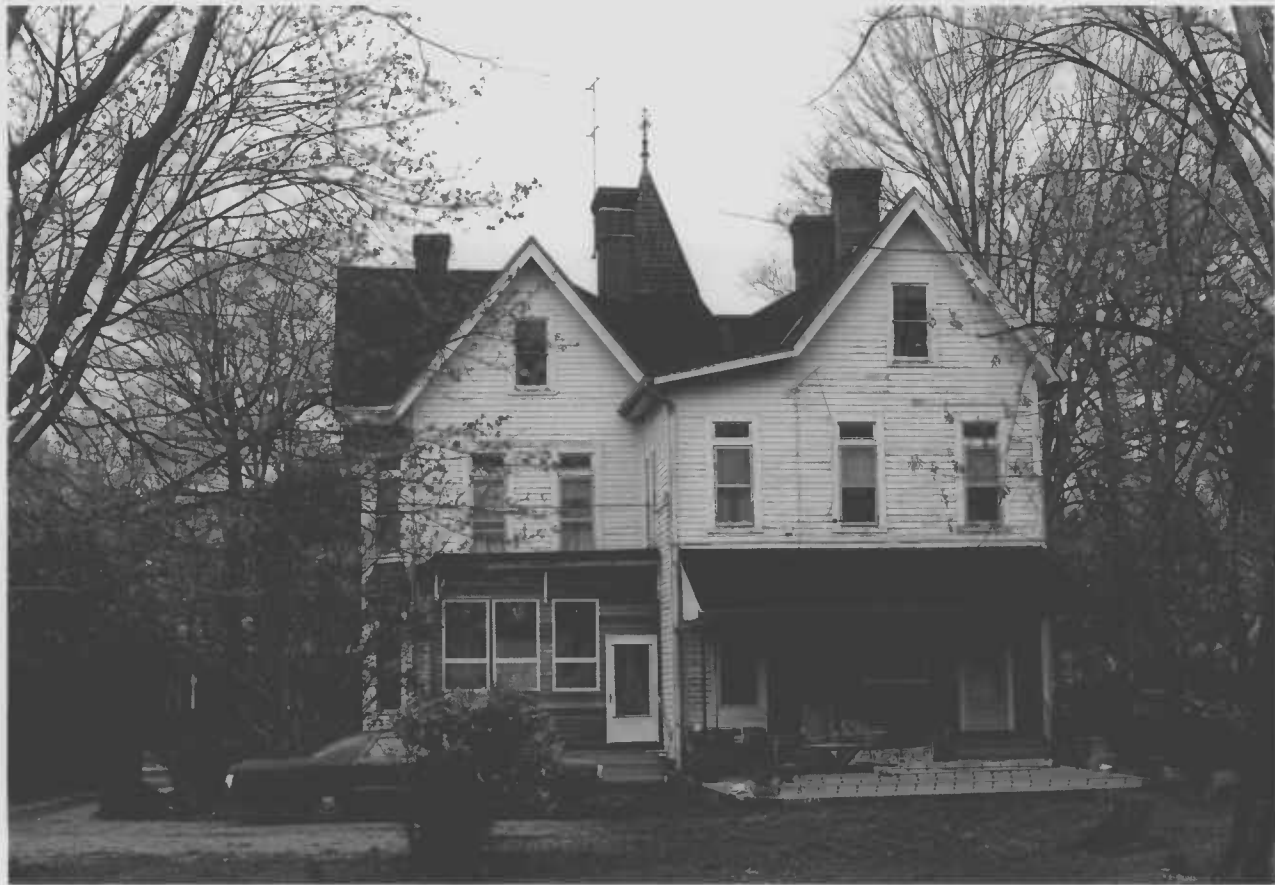
QA-399

Harper House  
South Commerce Street  
Centreville, Maryland  
Orlando Ridout V 1980  
Rear view from East

The rear facade is broken up into several planes and has been altered somewhat on the first floor. The original 1/1 windows with stained glass transoms still survive on the second story.
